Doppler ultrasonography and computed tomography angiography demonstrate positional occlusion of vertebral artery associated with one-sided destruction of the atlantoaxial lateral mass caused by rheumatoid arthritis: a case report.

Doppler Ultrasonography & CT Angiography for Diagnosis of Positional VA Occlusion

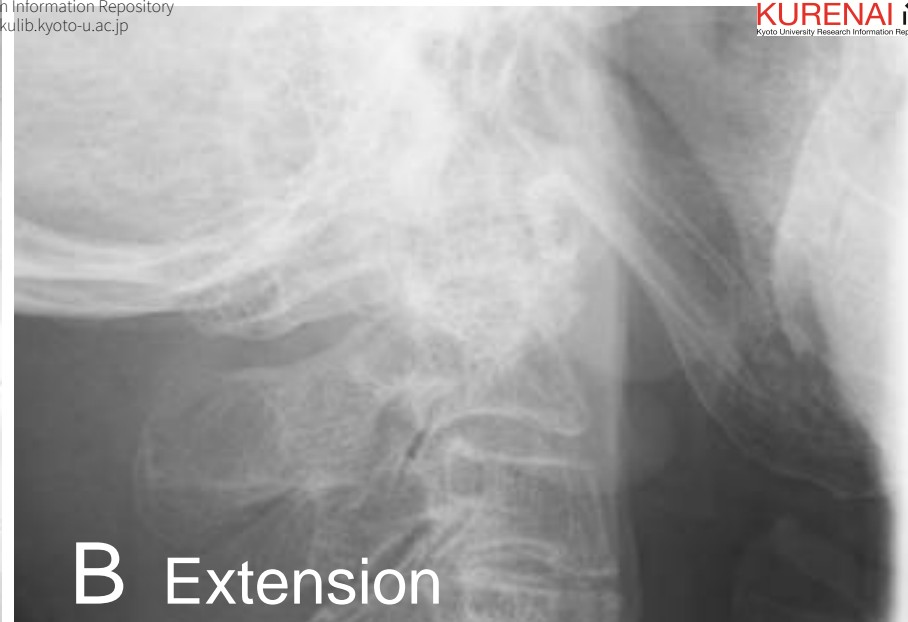
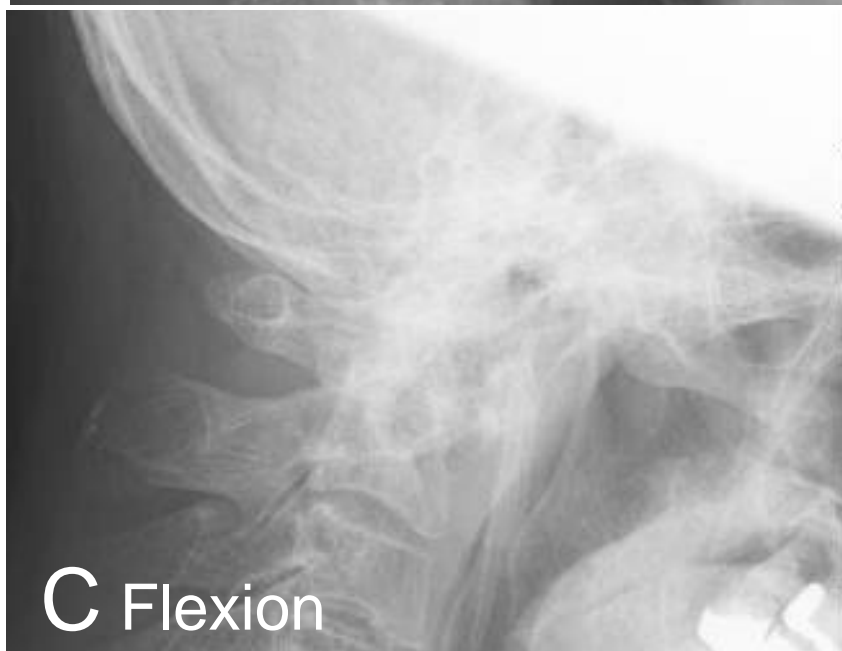
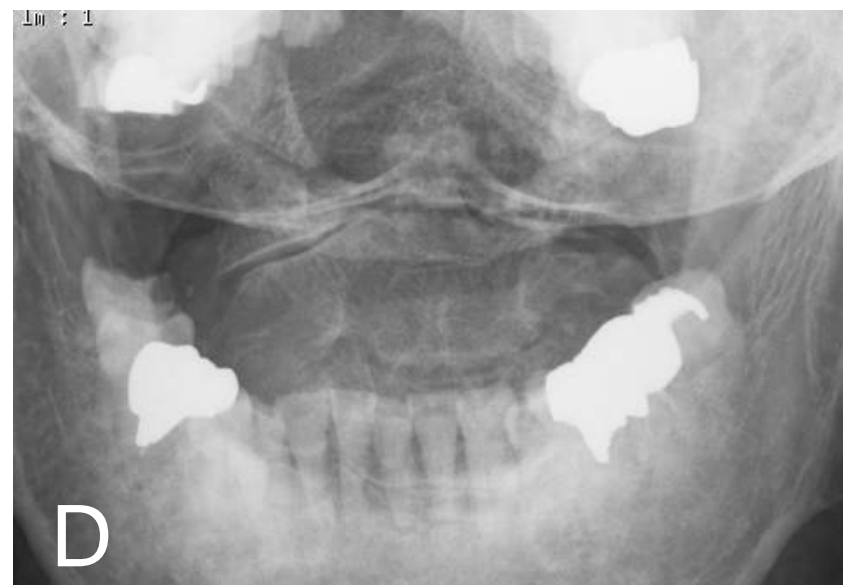
Figure 1

Lateral radiographs in the neutral (**A**), extension (**B**), and flexion (**C**) positions, and an open-mouth view (**D**). Atlantoaxial instability and vertebral instability were mild. Note that the left C1/2 joint space is not clear (**D**).

74 An 83-year-old man with a 20-year history of RA complained of severe neck pain. Three
75 months later, he complained of severe vertigo, with no visual field defect, when he leaned
76 his head in the left-anterior direction. Because of his severe left occipital pain, he was able
77 to sit for less than 10 minutes. When he lay on his left side, he always experienced vertigo.
78 There was no sign of a neurological defect, including cervical myelopathy or brain
79 infarction, in the neutral position. Lateral radiographs indicated mild AAI: the atlantoaxial
80 distances in the neutral, flexion, and extension positions were 4 mm, 5 mm, and 0 mm,
81 respectively, and his Redlund–Johnell value in the neutral position was 27 mm, indicating
82 mild AAI with mild vertebral subluxation (Fig. 1A–D). Enhanced cervical CT in the neutral

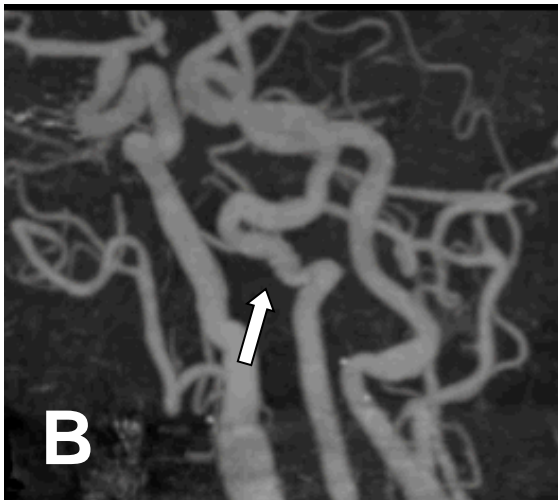
Figure 4

A lateral radiograph (**A**) and CT angiograph (**B**) after surgery. The arrowhead indicates the decompressed left VA.

We performed a posterior O–C2 fusion at the reduced position with an iliac bone graft (Figure 4A) instead of a C1–C2 fusion. It was difficult to achieve a secure grip on both C1 and C2 because of the severe destruction of the left lateral masses of C1 and C2. Therefore, a posterior transarticular screw was inserted on the right, and a C2 laminar screw and hook was used as an anchor because there was no space for a left transarticular screw or a C2 pedicle screw. The patient's severe vertigo disappeared in all positions immediately after the operation and there was no sign of postoperative infection or neurological defect. The patient was allowed to walk with a Philadelphia collar. The occlusion of the left VA disappeared completely (Figure 4B) and the PSV of the left VA recovered to 72 cm/s. Three months later, the O–C2 fusion was confirmed on CT and the patient reported no occipital pain or vertigo in any position.
